# FB/I-70 Lead-Based Paint Assessment

Address: 3847 Williams St

Property ID: 2283

Daily Quality Control Report  
VB/I-70

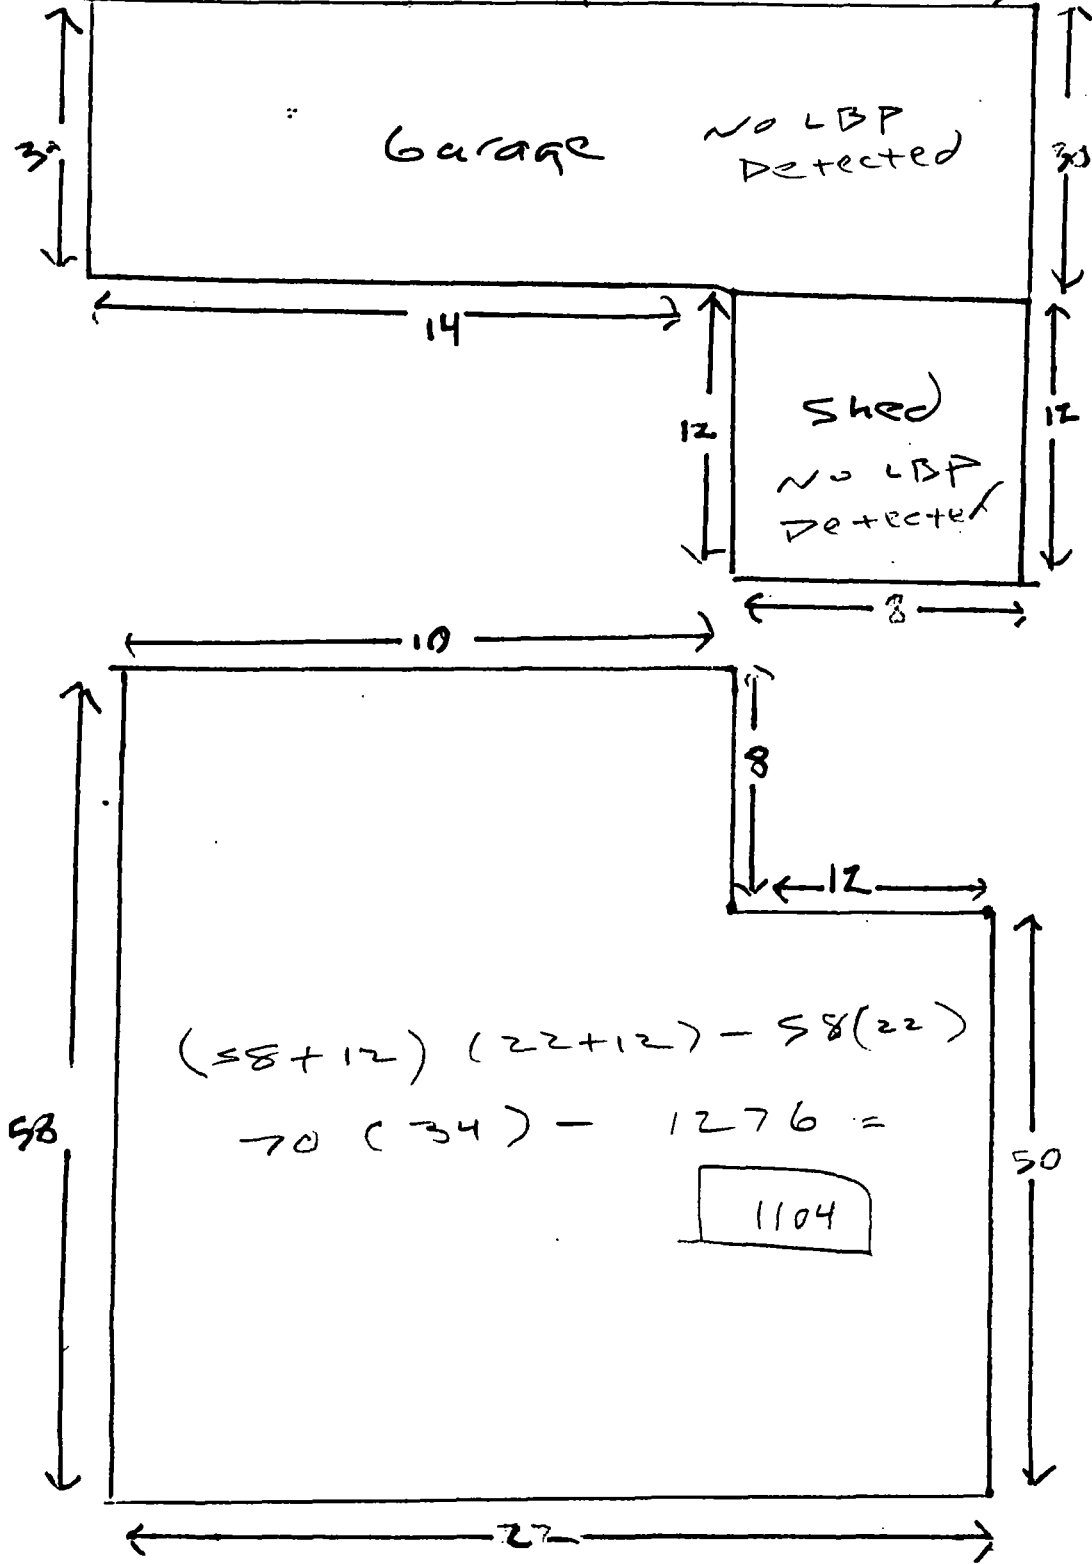
Plot Plan:

Can't get a hold of the owners
